CONNECTICUT RIVER BASIN
ATHOL, MASSACHUSETTS

CRESCENT STREET DAM
MA 00934

PHASE I INSPECTION REPORT
NATIONAL DAM INSPECTION PROGRAM

JUNE 1979

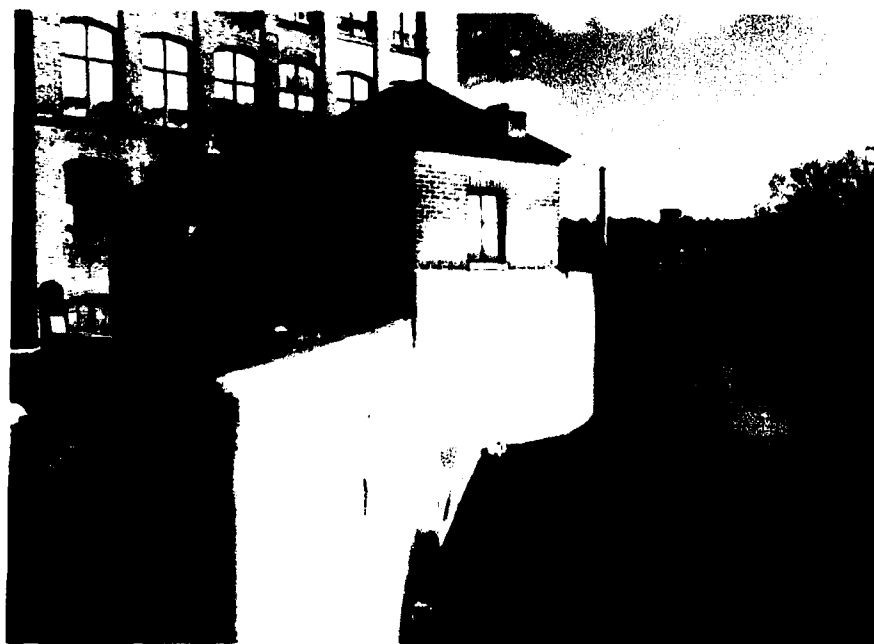
Starrett plant engineering personnel have advised that the condition first became evident about 10 years ago, and has been watched since then. The cracking has progressed slowly. It is reported that there may have been an increase in the rate about 4 years ago, and a decrease since then, although there is no record of actual crack measurements. Starrett personnel have not seen evidence of soil loss from the filled area.

- b. Dam - The Crescent Street Dam is generally in good condition. There was no observed evidence of significant seepage, lateral movement or significant erosion. The structures at the right abutment, as shown in Photo 11, do exhibit a crack parallel to the river indicating probable settlement of the fill in this area.

11. GATE HOUSE AT RIGHT ABUTMENT. NOTE PORTION OF CONTINUOUS CRACK IN RIGHT ABUTMENT WHICH PASSES THROUGH GATE HOUSE WALL (REPAIRED).

- (1) Monitor the various cracks in the brick and concrete surface structures behind the right abutment and at the right end of the inspection gallery more systematically than has been done in the past, by establishing points that will permit movement. Measure and evaluate movements on a monthly basis. In addition, examine the low portions of the perimeter of the filled area at approximately monthly intervals, when water levels permit, to see if there is evidence of loss of fill. If surface movements continue, investigate further by checking below-water portions of the adjacent walls and by drilling through the surface slab to check for subsidence of the underlying fill. If any of the measurements or observations disclose a major or worsening problem, a registered professional engineer should be retained to make a thorough investigation.
